# **The Debris Flow in Hachimantai, 1997 and Dissemination of Disaster Information**

On May 11, 1997, a large mud flow occurred in the national forest of Hachimantai Kumazawa, Kazuno City, Akita Prefecture. It became a large-scale disaster. The sediment of 2.5 million cubic meters fell: 16 households in Sumigawa hot springs and Akagawa hot springs were totally destroyed, and Route 341, the trunk road of this area, was cut. Fortunately, however, there were no victims.

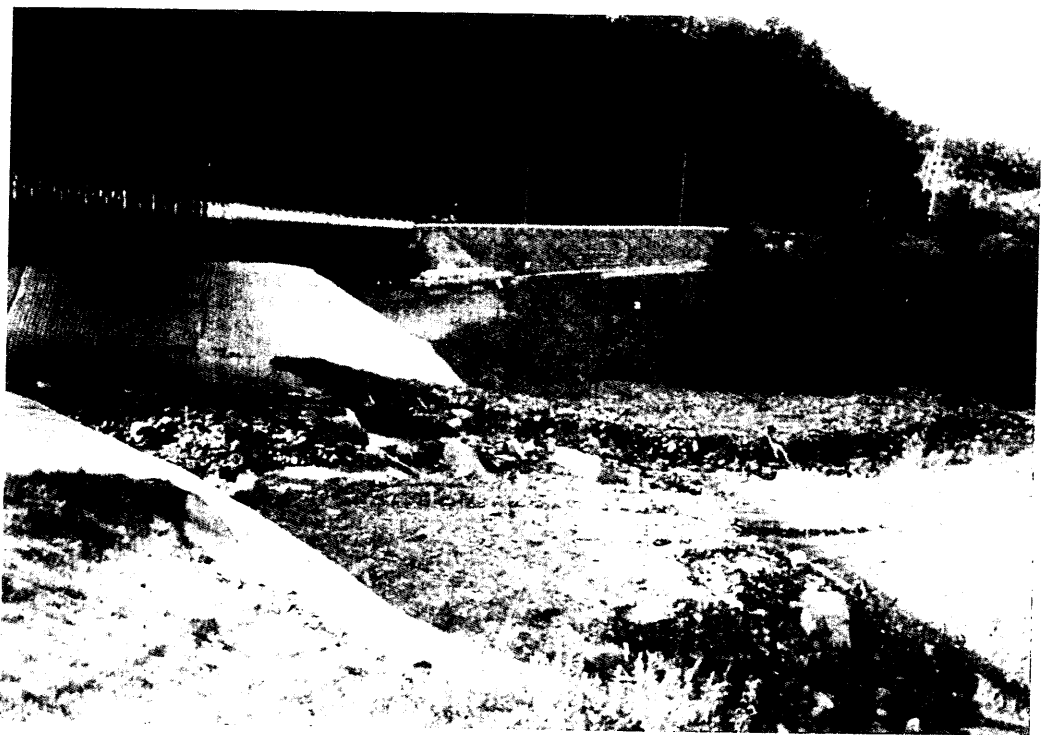
Picture 2 Akagawa bridge ruins washed away by the debris flow.

Just after that, an Akagawa hot spring Japanese Inn collapsed and was destroyed by the debris flow, and information was received that the Akagawa bridge was buried by the debris flow. So, he phoned the house of the head of Kumazawa hamlet in the lower reach, and ordered him to inform the hamlet of the precaution. It was directed that he directly transmit evacuation warnings to inhabitants in Kumazawa hamlet.

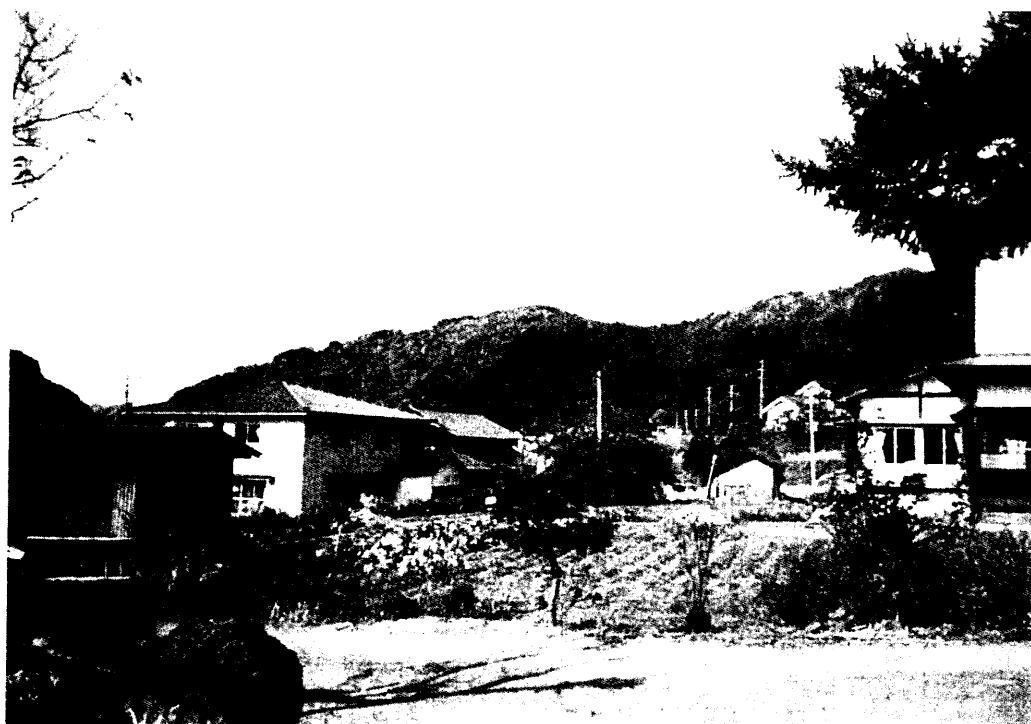
Picture 3 Around Kumazawa hamlet
